Installation Manual Double DIN Kit

CT23BM06

BMW 1 Series (E87 Facelift) 2007>

For vehicles with manual air conditioning, without iDrive

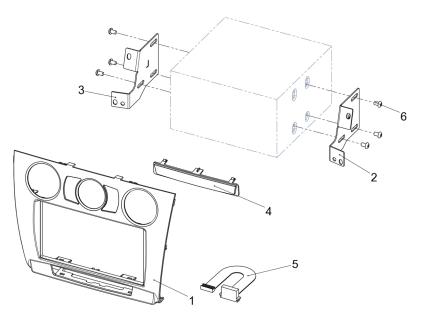
1

- 1. Fascia Panel
- 2. Mounting Bracket [Right]
- 3. Mounting Bracket [Left]
- 4. Blanking Cover*
- 5. Ribbon Cable

*only required for models without switch panel under climate control

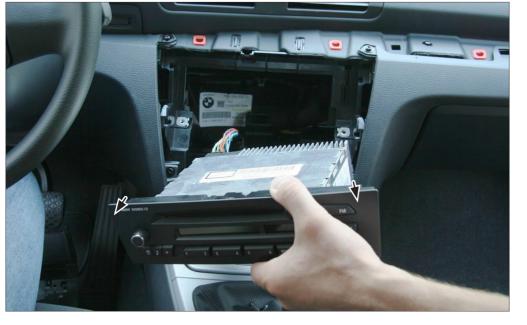
8. Remove the screws below the OEM head unit (See arrows)
